Type: Monthly Report 8270 Appendix

Subject: DCEC Residential Installation – February 2006

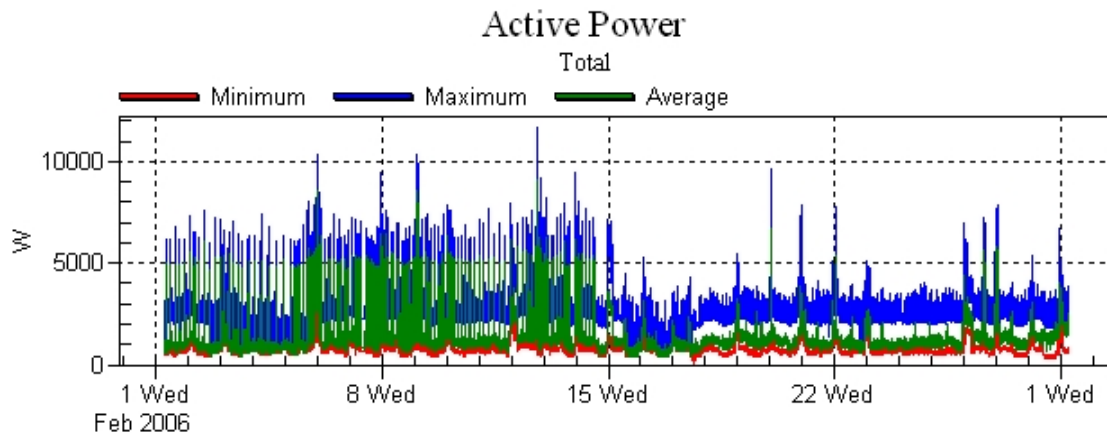
**Figure 1: Total system load. The hot tub was removed from the system February 14<sup>th</sup>.**

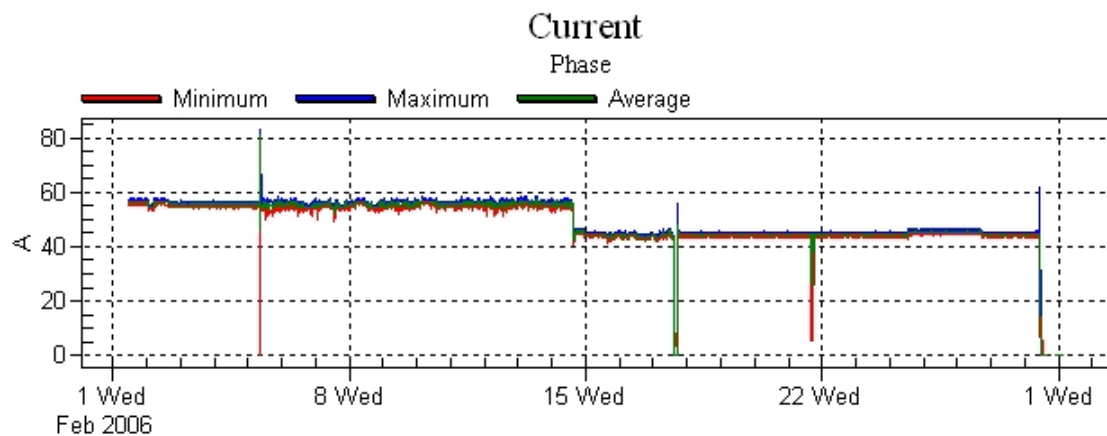
**Figure 2: Fuel cell output. February 14<sup>th</sup> the battery storage was brought online, and it reduced the fuel cell set point in order to match the house load / battery charging needs.**

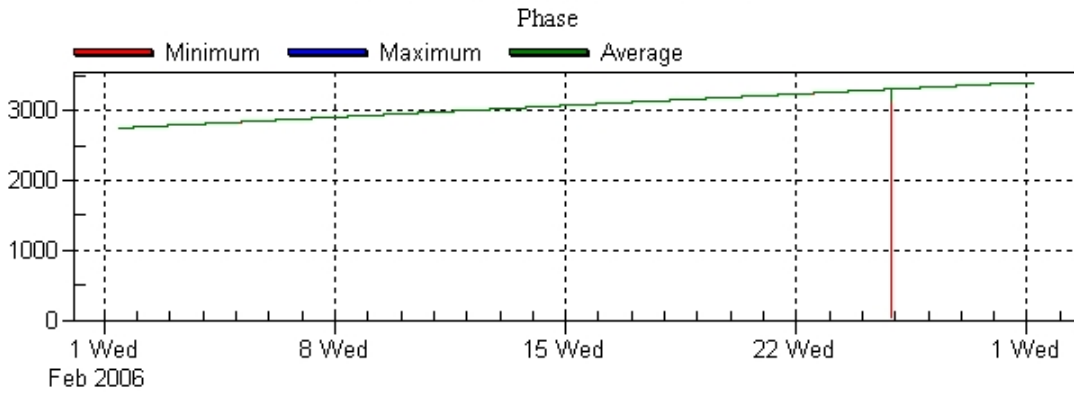
**Figure 3: Accumulated run time of fuel cell stack**

The fuel cell stack has now operated for more than 3000 hours most of the time at 30 to 60% capacity.

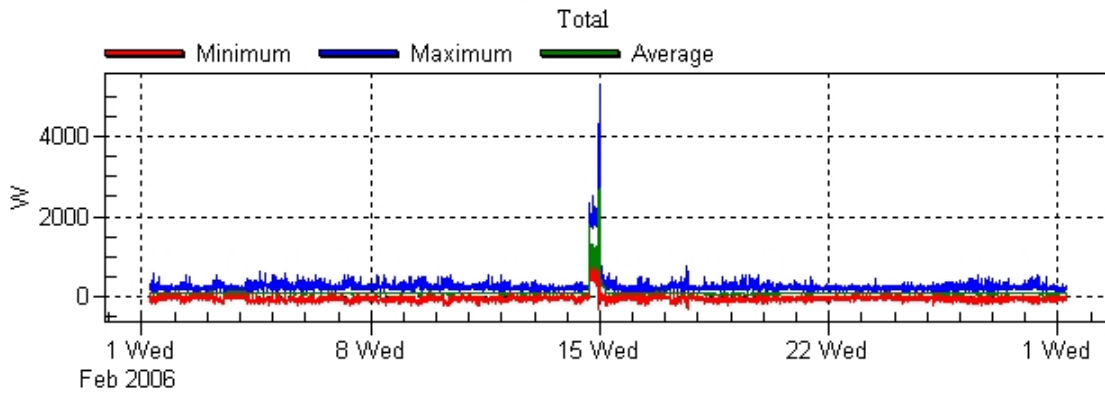
**Figure 4: Battery storage power output for the month**

Figure 4 shows that the battery storage delivered up to 5 kW during its operation February 14<sup>th</sup>. A further analysis of the system during the time the battery storage was online, shows that it performed as expected. In comparing the charts, it should be noted that some are reported in EST and some in GMT. In the future we may have to redraw the charts using the same time zone in order to make the comparison easier. Alternative, Enernex will have to reformat the timestamp on the server side.

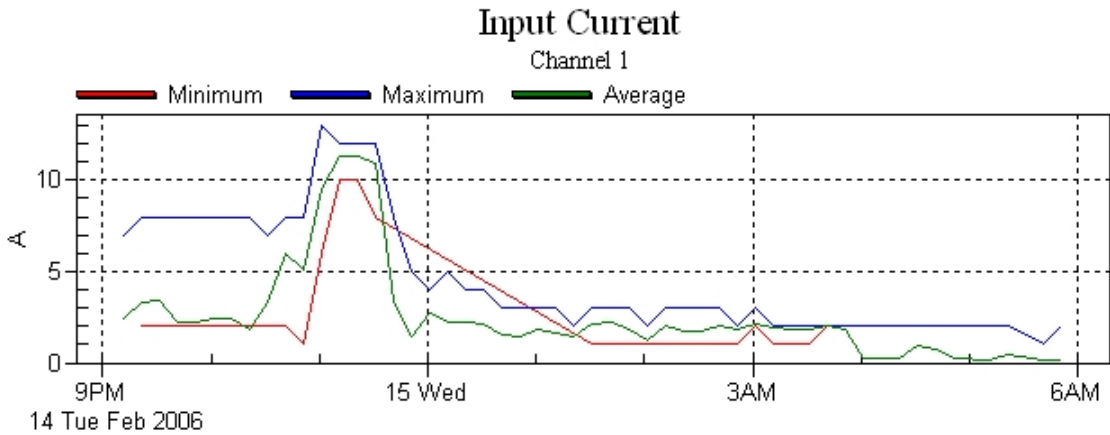
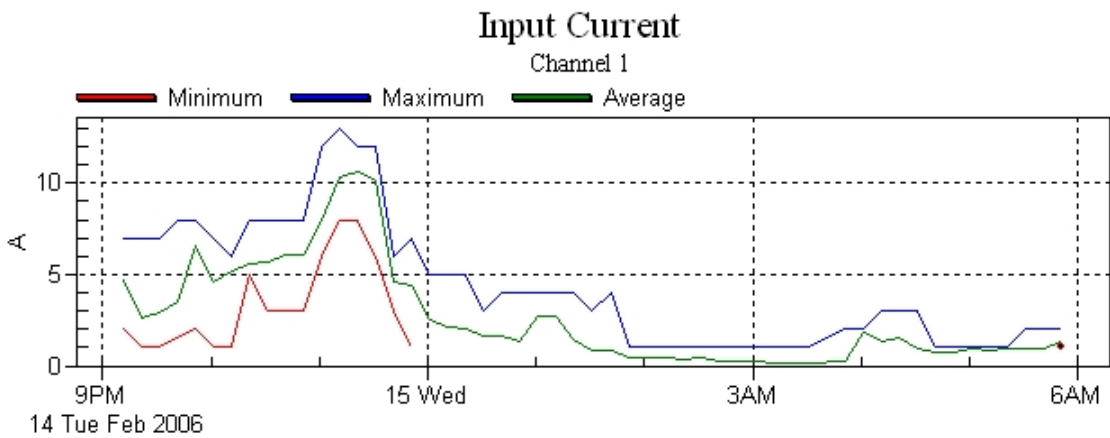
**Figure 6: Inverter 1 (top) and 2 (bottom) - Input current. Time is given in GMT, which is 5 hours ahead of EST.**

For unknown reasons no input data for the battery storage are available prior to 9PM GMT, but it can be seen how the storage system reduced the fuel cell set point and subsequent increased it a little to compensate for increased usage.

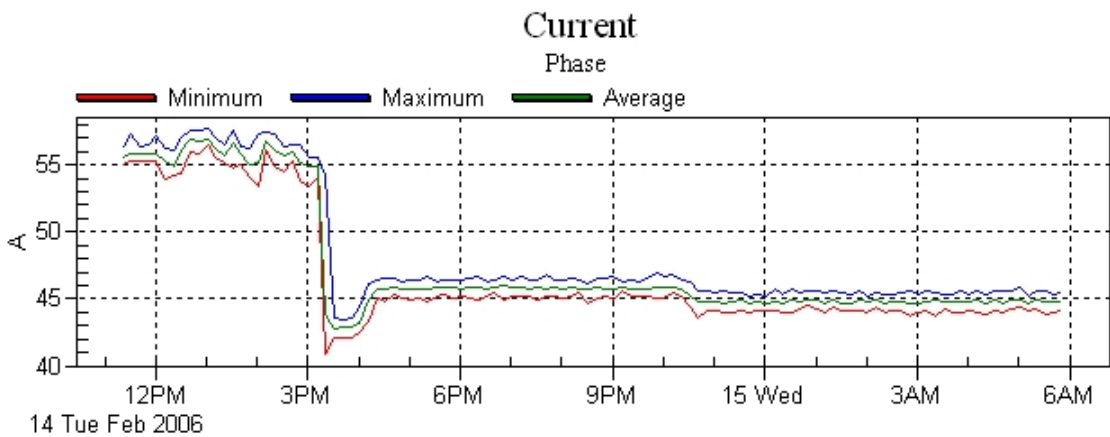
**Figure 7: Fuel cell output. Time is given in EST.**

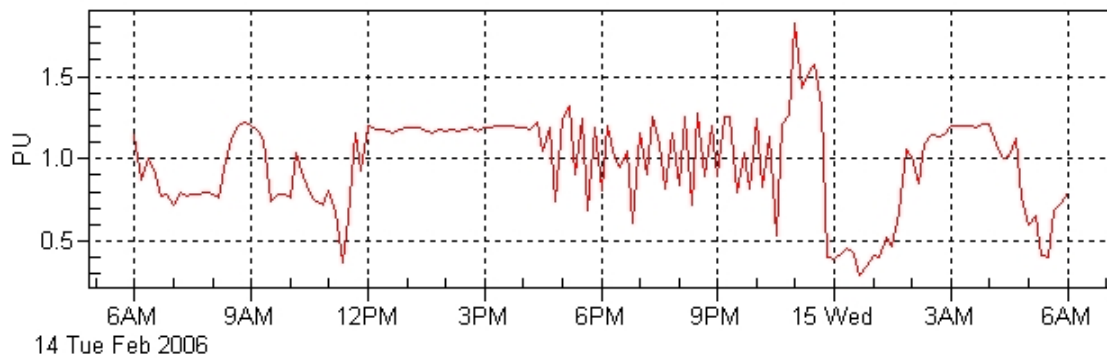
**Figure 8: Short term flicker. Values below 1 are considered good. When the battery storage was online the flicker became more erratic. Times are in GMT.**

The short term flicker reported in Figure 8 indicates that using the fuel cell in series with the energy storage unit introduced considerable short term flicker variation. Based on IEEE standards  $P_{st}$  should be below 1.0 95% of the time, and it is clear that this is not the case for this site. Even with the energy storage unit bypassed the site experience considerable flicker, but with less variation.

During our next visit to the site we will perform a thorough walk through to establish, if possible, the cause of this flicker
