Date: 15-Apr-06

Type: Monthly Report 8270 Appendix

Subject: DCEC Residential Installation – March 2006

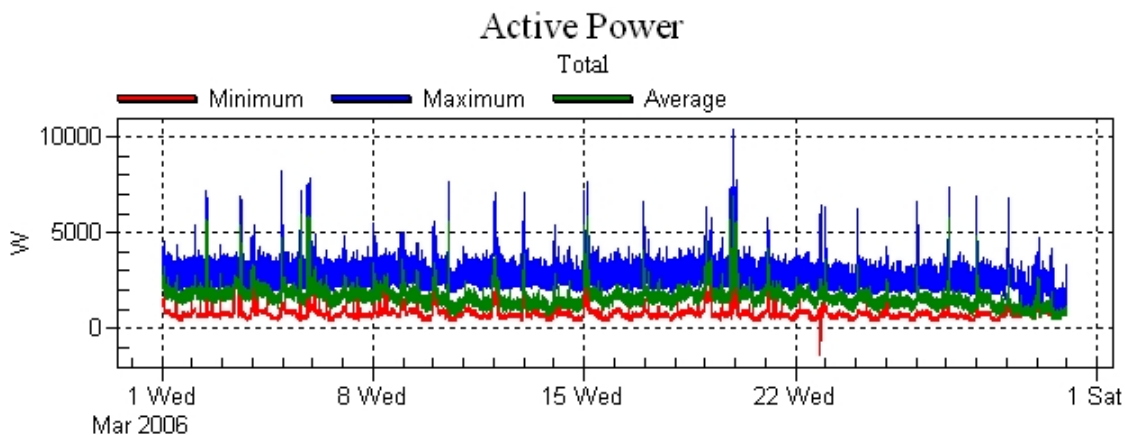
Figure 1: Total system load (Service Entrance). Even without the hot tub the load reached more than 10kW at times.

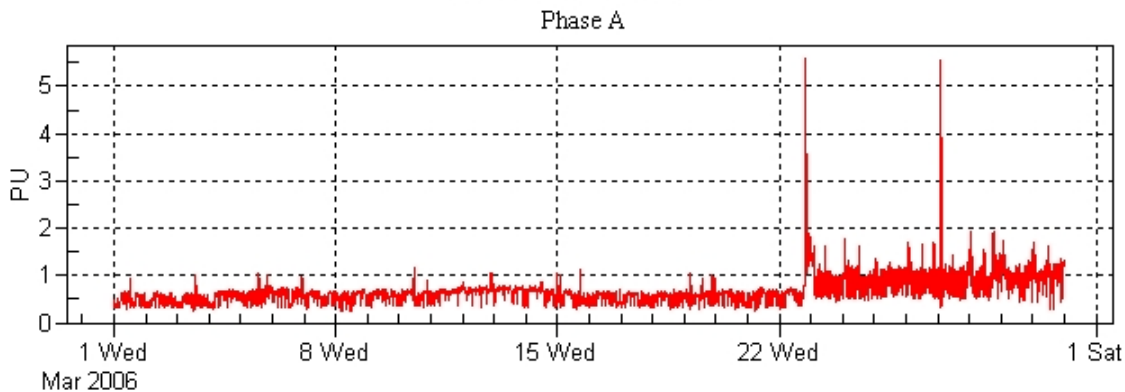
Short Term Flicker

Figure 2: Short term flicker. A PU value above 1 corresponds to more than 50% of the population will notice flicker in an incandescent light bulb.

As it can be seen from Figure 2 the flicker went up significantly after the PowerTower was brought online again March 23rd. Based on IEEE standards P_{st} should be below 1.0 95% of the time, and it is clear that this is not the case for this site. Even with the energy storage unit bypassed the site experience considerable flicker, but with less variation. We used an oscilloscope to map the AC sine wave at various places in the system. We are currently speculating that the increased flicker is due one of two scenarios: Either it is because the PowerTower oscillate between charge and discharge of the batteries, which changes the output voltage, or it could be due to a compounded effect of using two pseudo-sine wave inverter in series.

One way to prove if the switching between charge and discharge is the main cause of the flickering would be to prevent the PowerTower from charging during day time or until a given battery voltage has been reached.

Two other solutions would be to substitute the incandescence light bulbs with fluorescents, LED, or halogen lights, which are less sensitive to voltage fluctuations, or we could use the DC power directly from the fuel cell, which would bypass both the fuel cell inverter and the PowerTower charger.

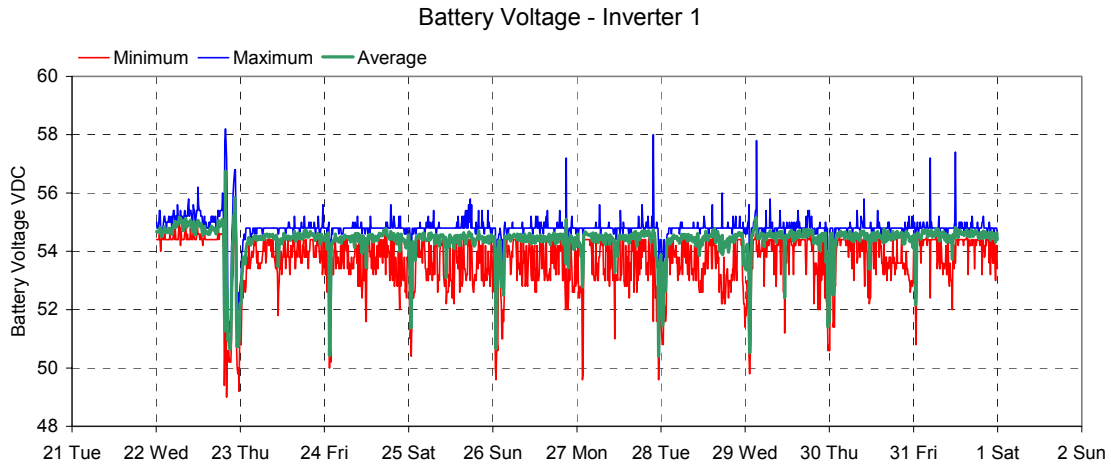
Figure 3: PowerTower battery voltage (Inverter Leg 1)

As seen in the figures above, the battery voltage fluctuates a lot and the current shifted frequently between discharge and charge. This would indicate that the fuel cell output is relative well matched with the load and the batteries are hardly discharged during normal operation

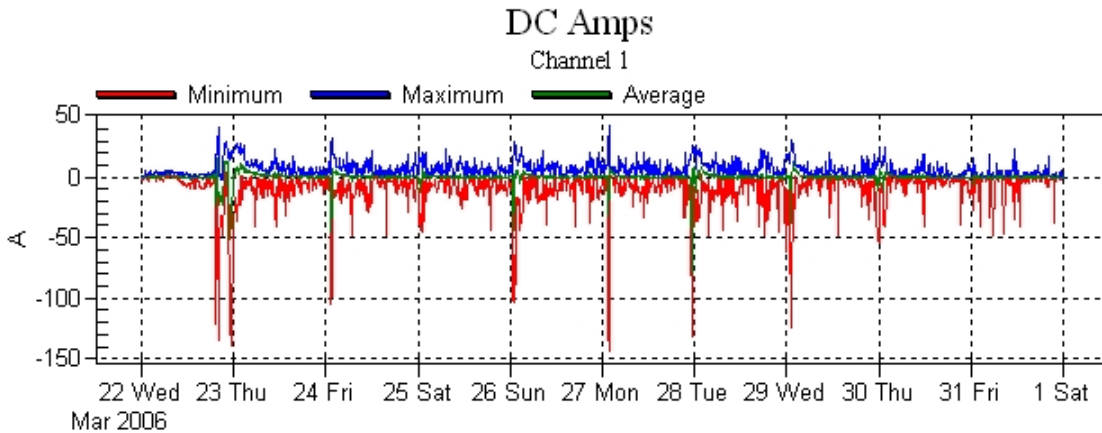
Figure 4: PowerTower battery current (Battery Monitor). Negative current equals discharge and positive equals charge.

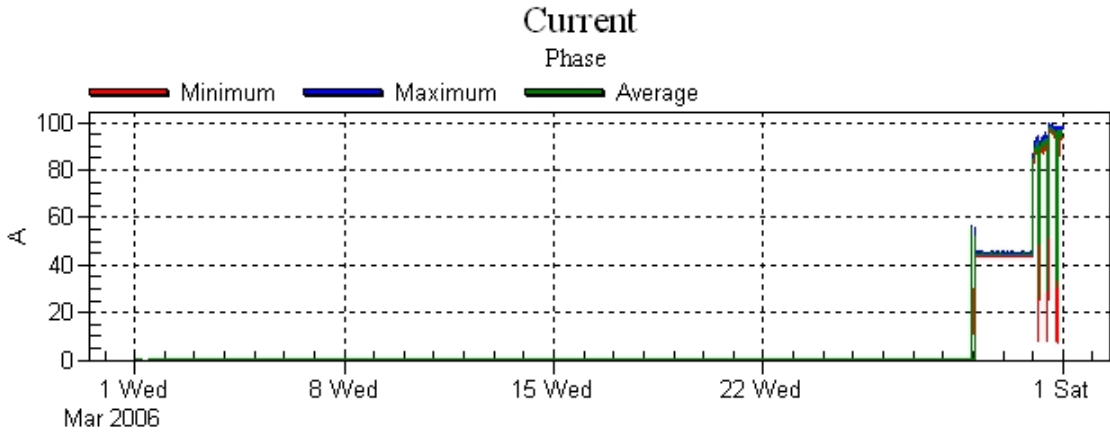
Figure 7: Fuel cell output (PlugPower Fuel Cell). March 1st the fuel cell went off-line and was only brought back on-line March 28th. The battery storage was brought online March 23rd, and it has been adjusting the fuel cell set point in order to match the house load / battery charging needs.

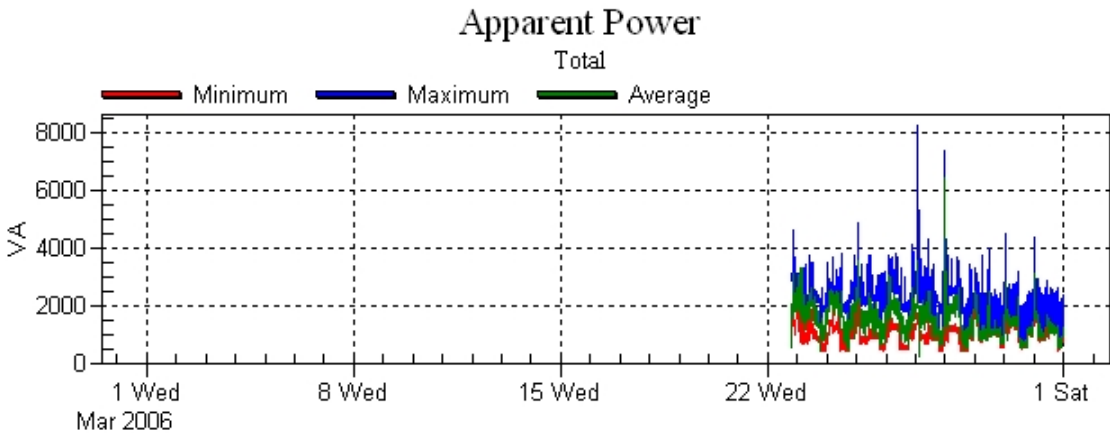
Figure 9: Battery storage power output for the month (PowerTower Output).

Figure 9 shows that the battery storage delivered up to 8 kW during its operation in March. A further analysis of the system during the time the battery storage was online, shows that it performed as expected.
