<b>Date:</b> 15-Jun-06	<b>Type:</b> Monthly Report 8270 Appendix	<b>Author:</b> Ib I. Olsen
<b>Subject:</b> DCEC Residential Installation – April/May 2006

### Installation Summary:

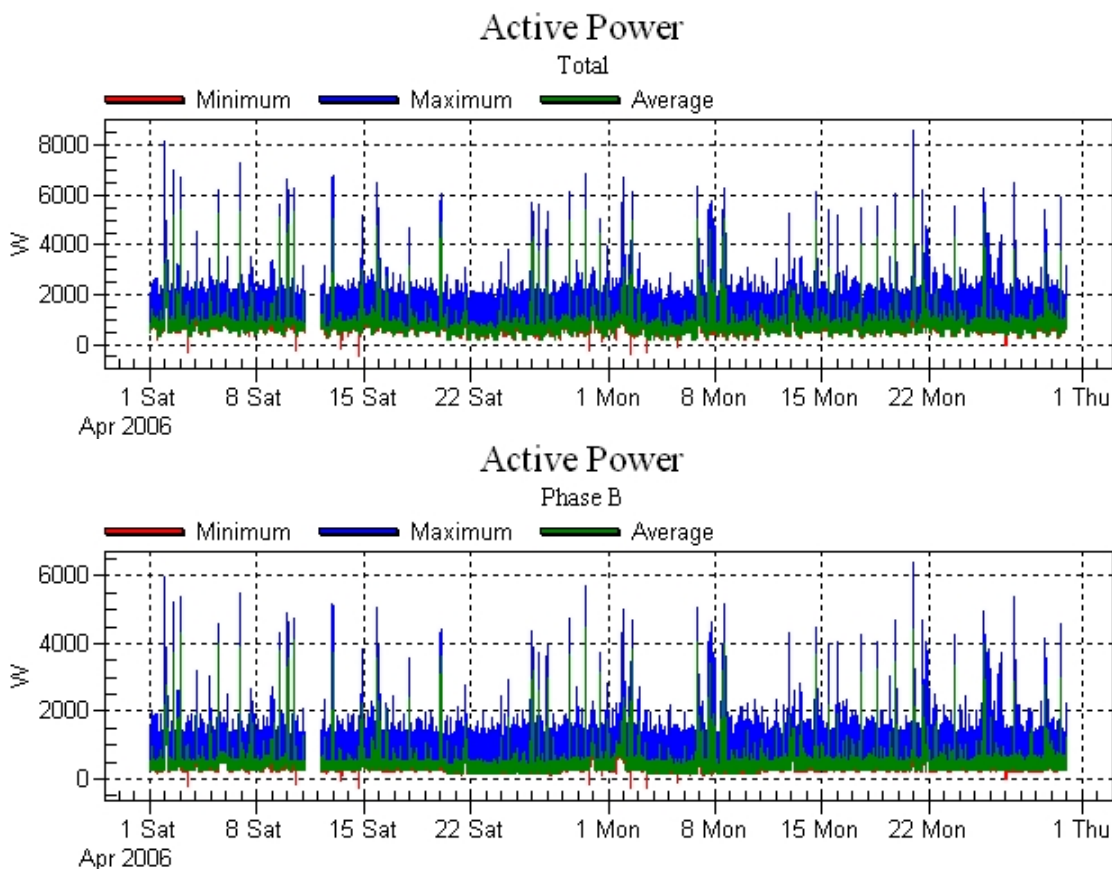
The PowerTower was bypassed at the end of May after the house owner overloaded the system, which resulted in significant voltage drop.

**Figure 1: Total system load (Service Entrance). Even without the hot tub the load reached more than 8kW at times, and phase B would reach more than 5.5 kW, which is the rated limit of the inverter.**

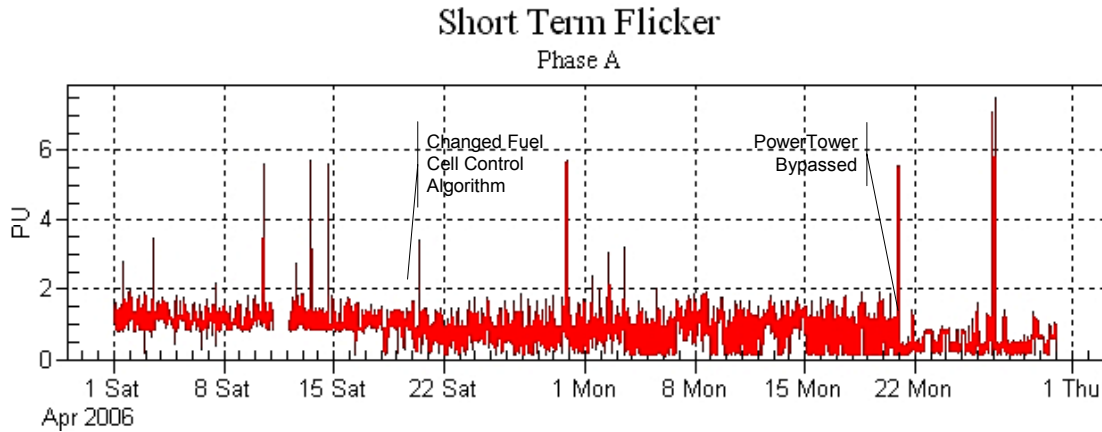
Short-term flicker problem continues to be an issue. In April we changed the algorithm for changing the set-point of the fuel cell to force deeper discharge of the batteries, and it did improve on the flicker, but it did not bring it down to ‘utility grade’

**Figure 2: Short term flicker. A PU value above 1 corresponds to more than 50% of the population will notice flicker in an incandescent light bulb.**

As it can be seen from Figure 2 the flicker went down after the fuel cell control algorithm was changed, but it still is not as good as the utility alone. We had a phone conference with Enernex, and they claim that the behavior is not atypical of a source-limited installation.

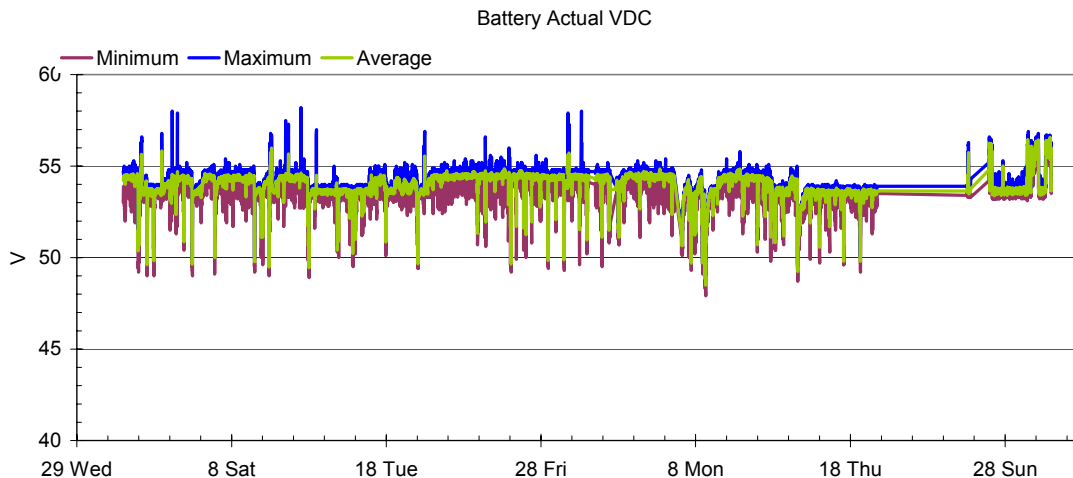
As seen in Figure 3 the change in fuel cell algorithm did increase the battery usage and reduced the charge frequency, but clearly not enough to prevent the flicker. Unfortunately, without turning of the fuel cell it is not possible to increase the battery usage more. However, this can be demonstrated in the grid / storage scenario.

**Figure 3: PowerTower battery voltage (GP PowerTower Battery)**

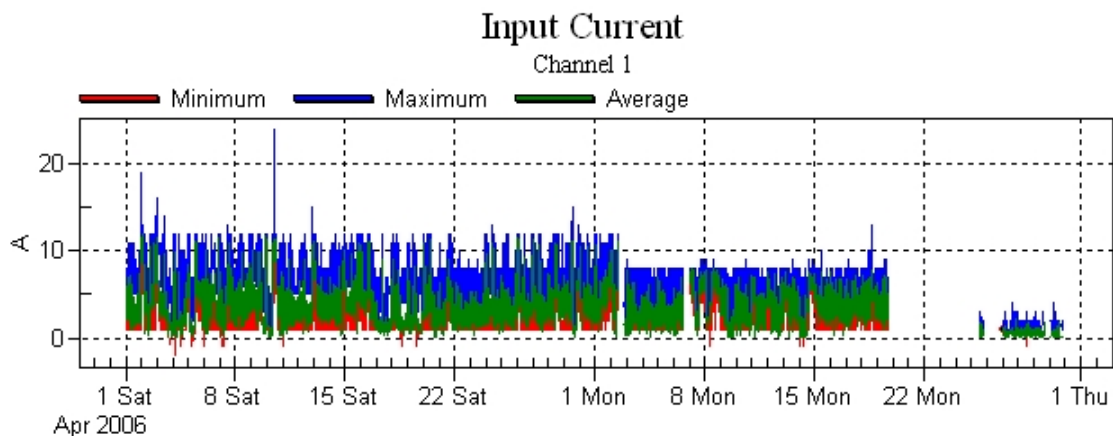
**Figure 6: Inverter 2 input current (GP PowerTower Inverter B)**

Compared to March the input current was kept at a much lower level in this period, which might have been detrimental for the fuel cell performance, as it stopped working two times in the period.

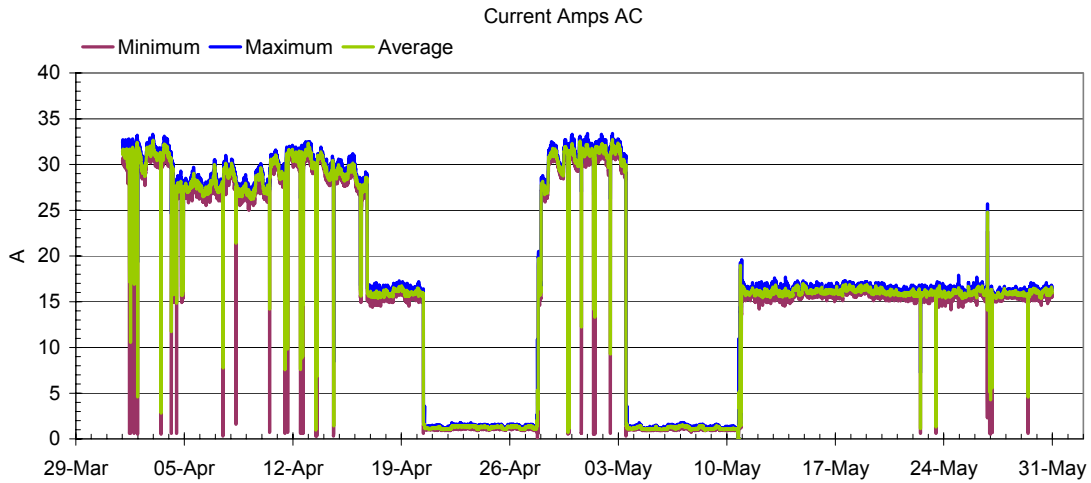
The PowerTower was online for most of the period, until it was bypassed at the end of May because some severe voltage dips. The fuel cell ran most of the time, but was down for seven days at the end of April and six days in the beginning of May.

**Figure 7: Fuel cell output (PP Fuel Cell Output). Fuel cell went off-line twice in this period.**

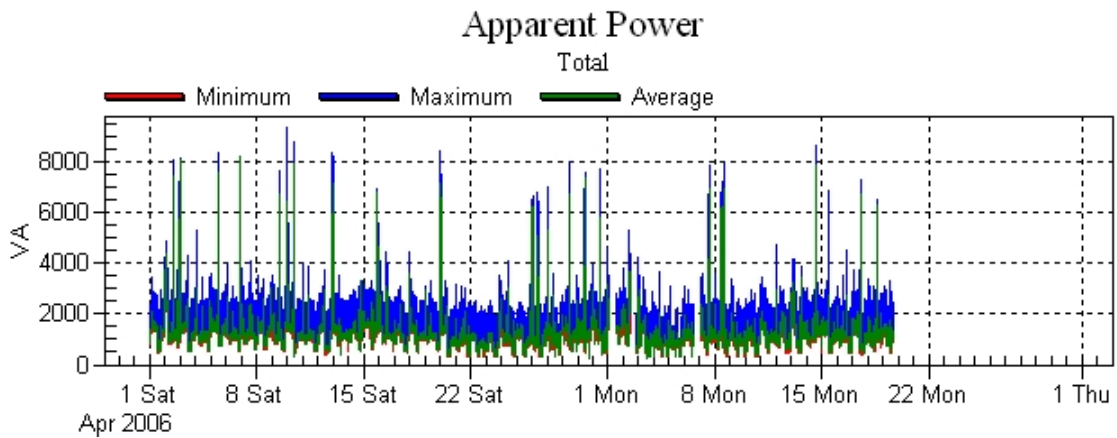
**Figure 9: Battery storage power output for the month (GP PowerTower Output).**

Figure 9 shows that the battery storage delivered over 8 kW during its operation in April and May. A further analysis of the system during the time the battery storage was online, shows that it performed as expected.

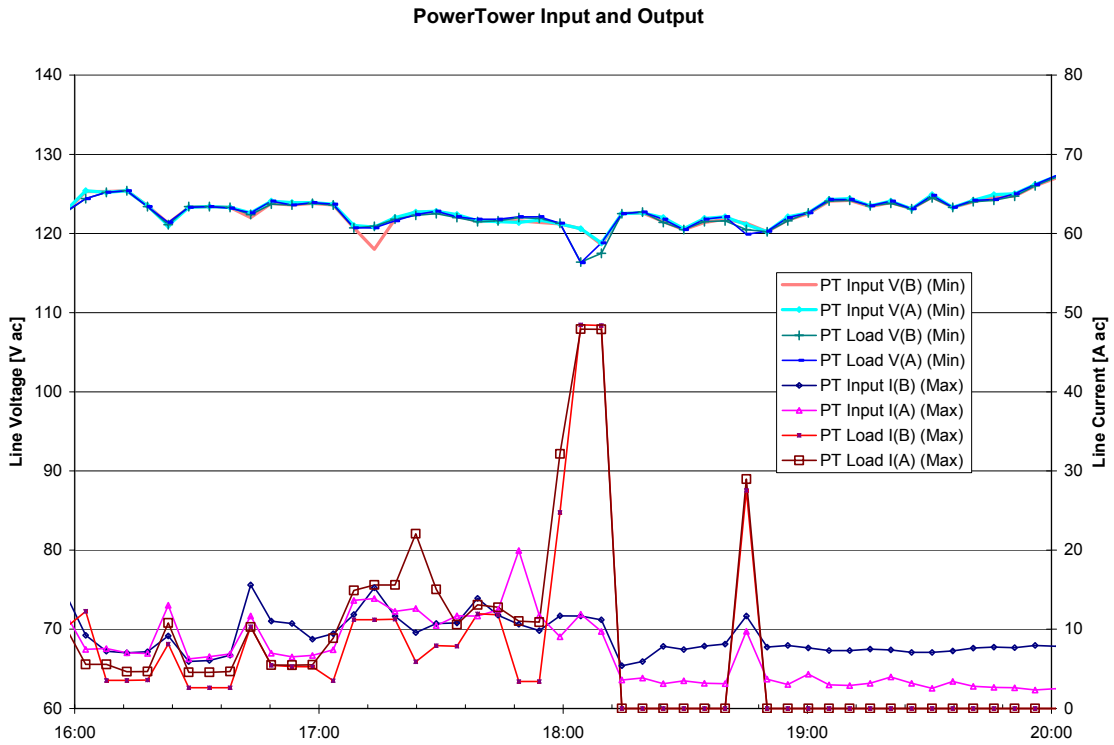
At the end of May the house owner experienced significant voltage drop / light flicker and he pulled the by-pass switch. A closer look at the power demand in and out of the PowerTower in Figure 10 shows that the voltage dip was caused by sudden increase in current demand on both phases. In fact the increase corresponded to 10kW and the inverters were maxed out at 5.6 kW each, which is slightly above the rating. At this point we do not know what the house owner tried to power, but it was not disconnected when he tried to reinsert the PowerTower again 45 minutes later.

**Figure 10: PowerTower input and load just before and after voltage dip and subsequent by-pass.**
