<b>Date:</b> 15-Jun-06	<b>Type:</b> Monthly Report 8270 Appendix	<b>Author:</b> Ib I. Olsen
<b>Subject:</b> DCEC Residential Installation – April/May 2006

### Installation Summary:

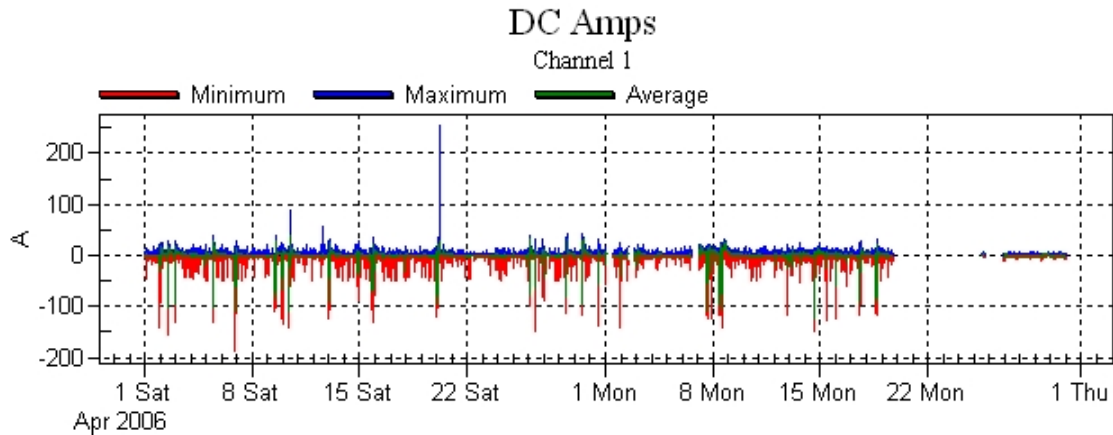
As seen in Figure 3 the change in fuel cell algorithm did increase the battery usage and reduced the charge frequency, but clearly not enough to prevent the flicker. Unfortunately, without turning of the fuel cell it is not possible to increase the battery usage more. However, this can be demonstrated in the grid / storage scenario.

**Figure 4: PowerTower battery current (Battery Monitor). Negative current equals discharge and positive equals charge.**

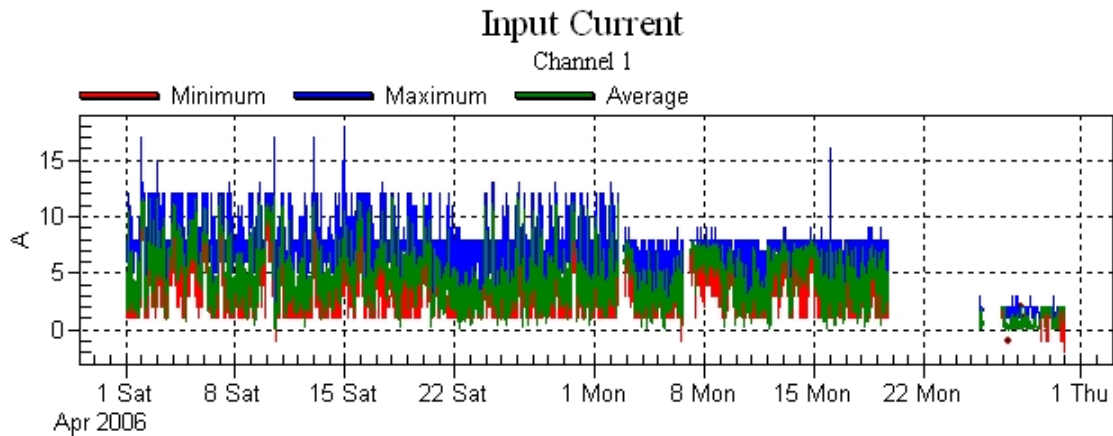
**Figure 5: Inverter 1 input current (GP PowerTower Inverter A)**

Compared to March the input current was kept at a much lower level in this period, which might have been detrimental for the fuel cell performance, as it stopped working two times in the period.

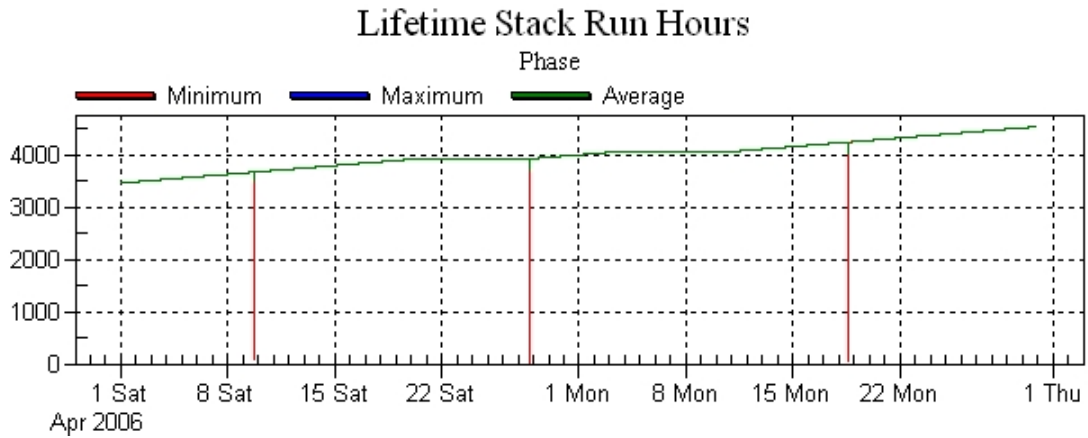
**Figure 8: Accumulated run time of fuel cell stack (PP Fuel Cell Internal).**
